Core Acceptance Criteria

Axle Modulators for WABCO applications

AFTERMARKET

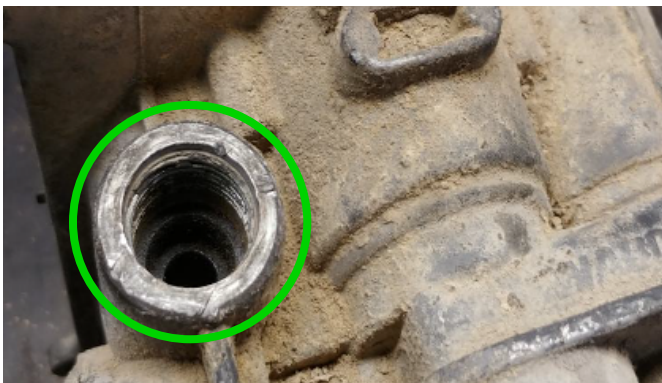
Damaged ports

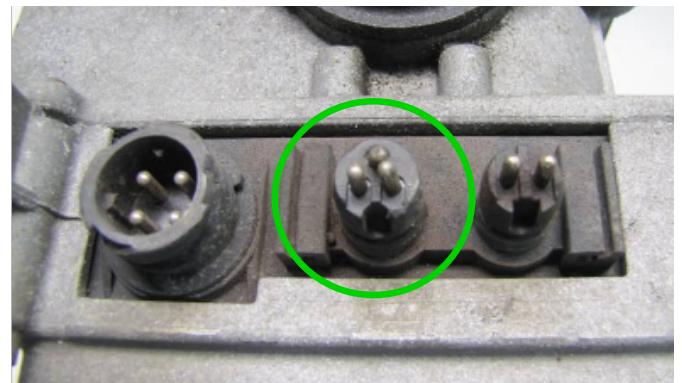
Bent Pins, Scratches on connector
(generation 1, 480103XXXX)

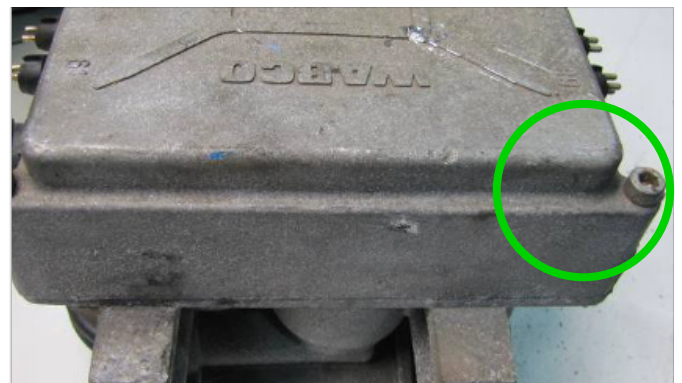
Cutted, damaged or missing cover flips

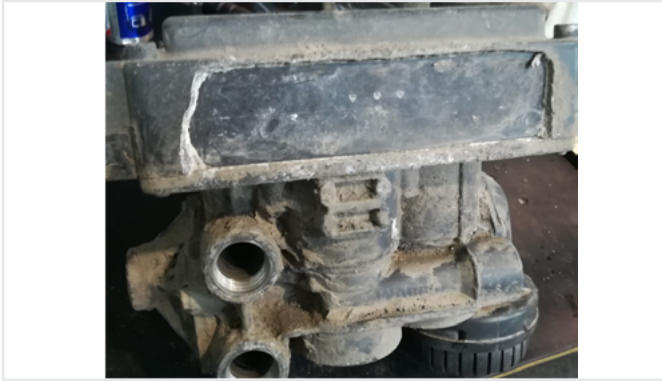
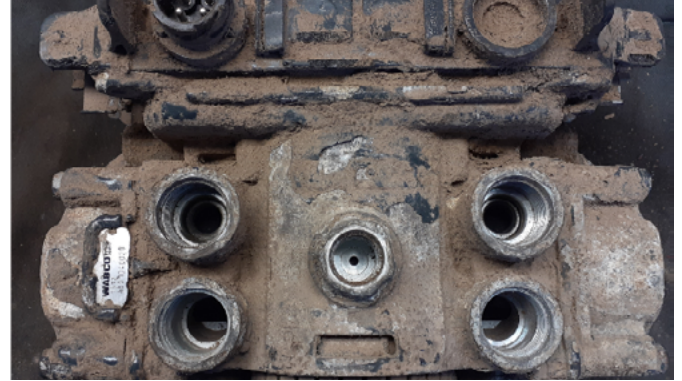
Surface contamination, dirt.

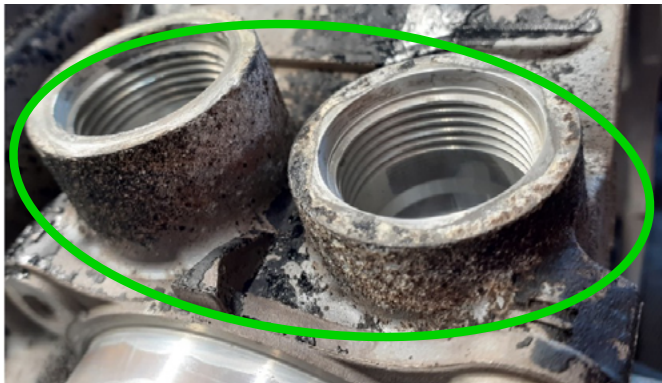
Corroded ports

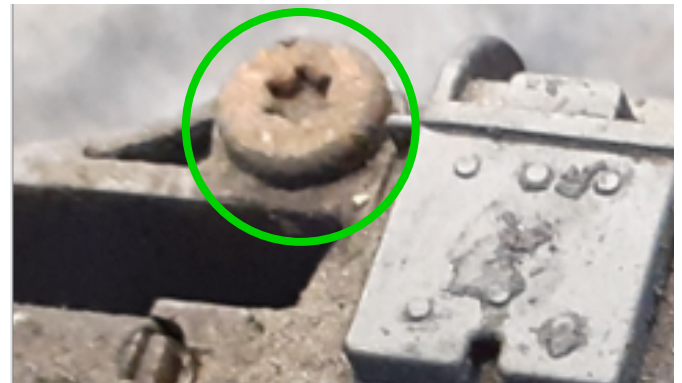
Corroded screws

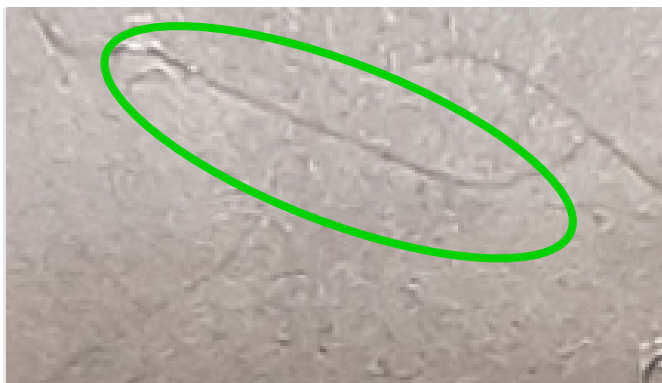
Scratches on external surface

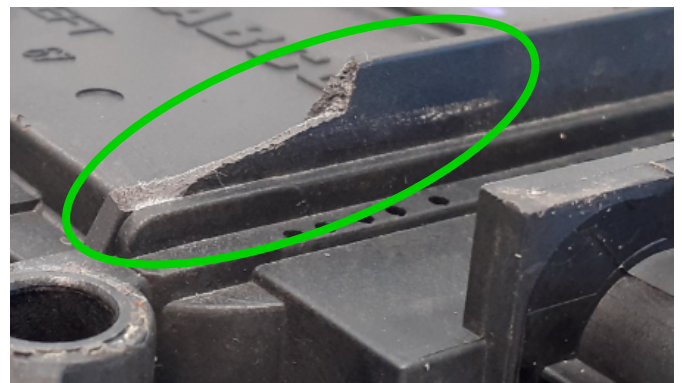
Missing small parts of plastic cover

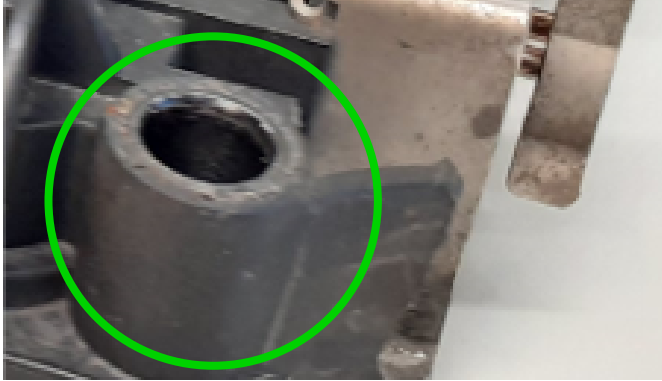
Broken rib of plastic cover
